भारत का राजपत्र The Gazette of India

“मैसर्स सेन्ट्रल कोलफील्ड लिमिटेड की सेन्ट्रल सौंडा कोलियरी में घटित बड़ी दुर्घटना की, जिसमें 14 व्यक्तियों की मृत्यु हुई थी, के संबंध में जांच न्यायालय की रिपोर्ट।”

**15 जून, 2005 को मेसर्स सेन्द्रल कोलफिल्डस् लिमिटेड के
सेन्द्रल सौंडा कोलियरी में 14 व्यक्तियों के प्राणघातक
दुर्घटना के संबंध में जाँच अदालत का प्रतिवेदन**

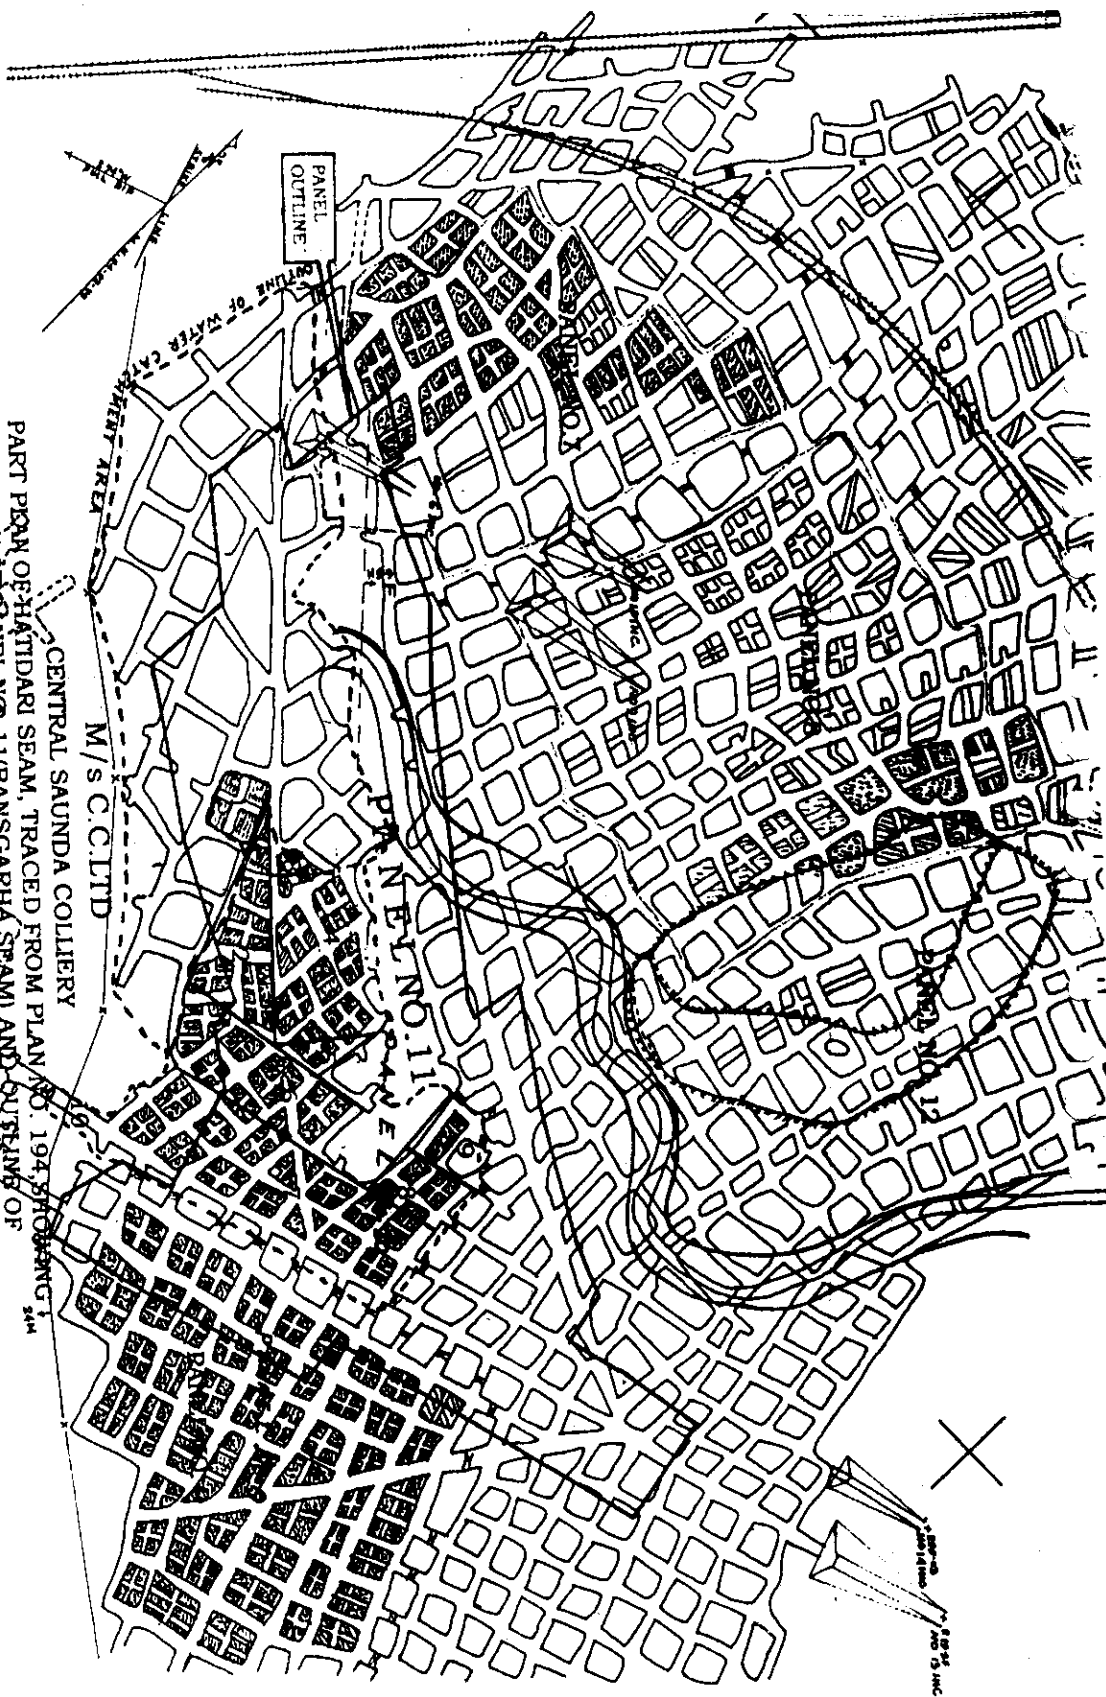
4.2.1 Big boulders of sand stone were found at places as mentioned below.

4.2.2 Rail at the junction of 17 X cut and 27th level was found twisted/ damaged.

4.2.3 Six tubs at the junction of 17 X cut and 26th level were found completely damaged/ twisted.

4.2.4 Heap of sand, mixed with mud was found at many places in the area.

4.2.6 Goaf edge boulders were observed at 27½ level off 16 X-cut.

4.3 Photographs of boulders, damaged tubs, rail, stones at the goaf edge taken during inspection, are enclosed.
